Inspector's Daily Report

IDR Sheet	1	of	2	Sheets	Final Record Book	Page
Contract	C-7852			Day	Thursday	
				Date	June 17, 2010

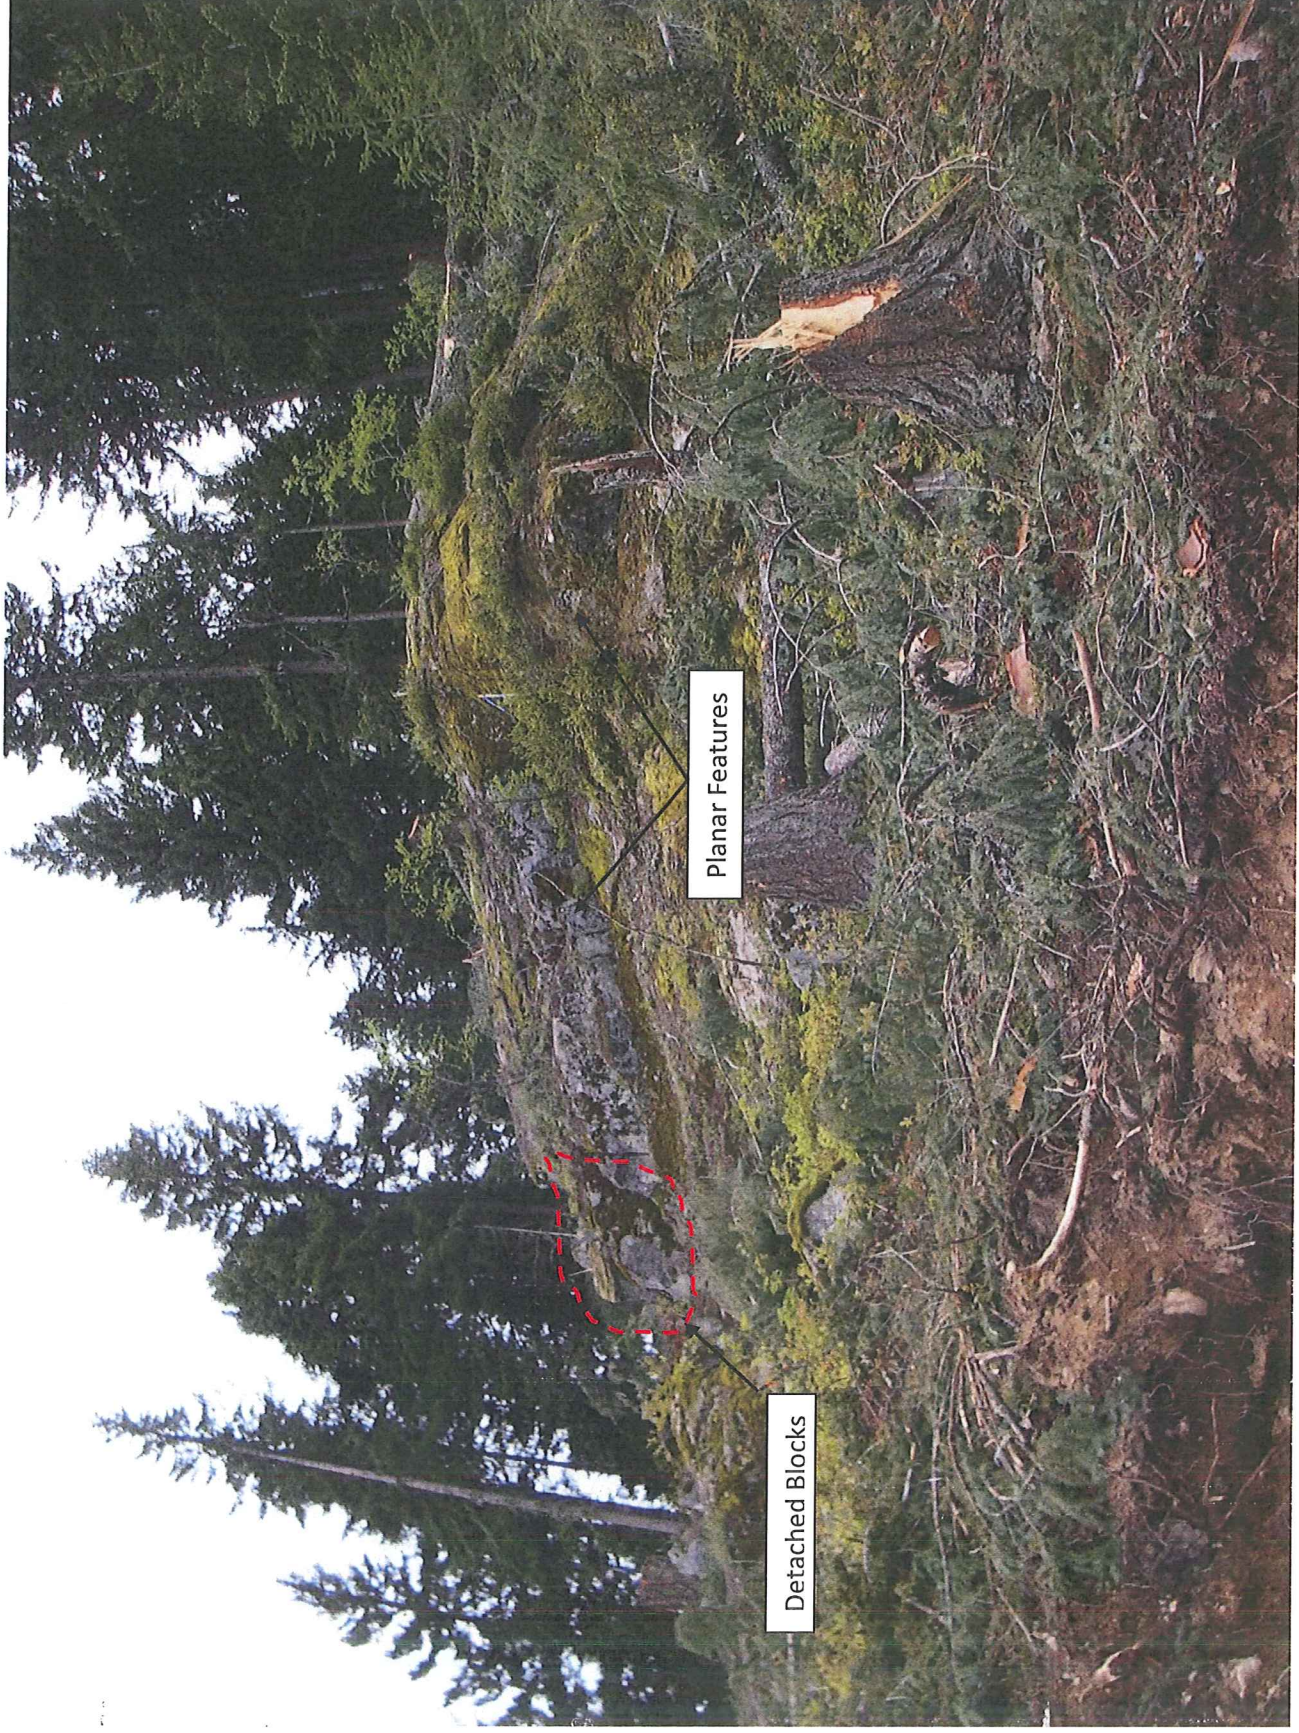
Figure 1. A photograph looking at the rock outcrop located at approximate station 1334+00.

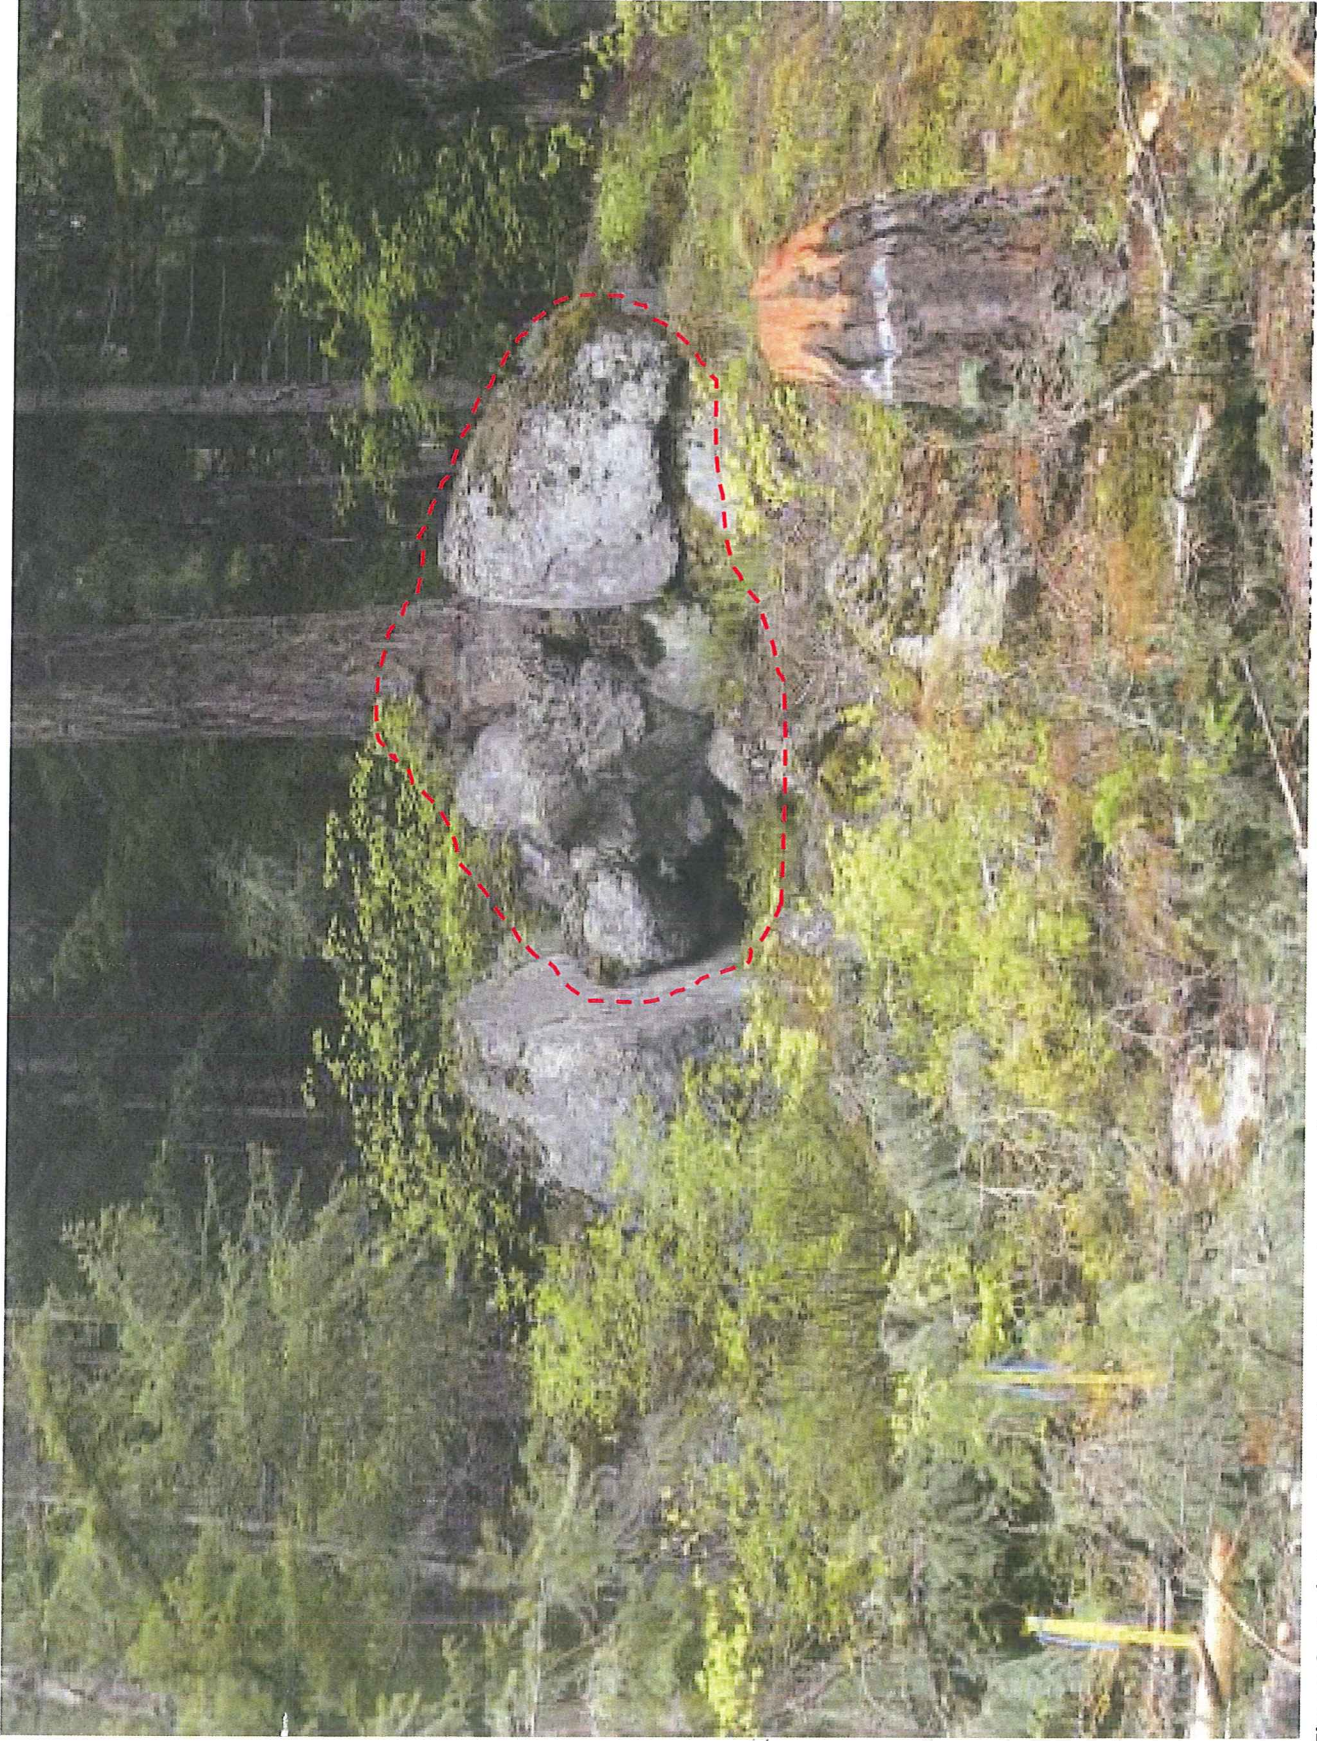
I arrived on site around 11:30 am and met with Brad Schut and Norm Norrish. Brad indicated that there were a few locations he wanted the Geotechnical Division to take a look at. The first two locations were located above the cut line at approximate LW stations 1334+00 and 1335+00. The first location (LW station 1334+00) consisted of a rock outcrop with large planar features adversely oriented towards the highway with a few detached blocks (Figure 1). The second location (LW station 1335+00) consisted of a mass of detached blocks (Figure 2). Norm and I both indicated to Brad that the first location likely needed stabilization of the planar features and removal of the detached blocks and the second location most likely needed removal of the detached blocks. Norm indicated that B. Stricker would be on site later in the week to map the two outcrops so analysis and design could be completed.

Figure 2. A photograph looking at the rock outcrop located at approximate station 1335+00. Note the large mass of detached blocks (red dashed line).

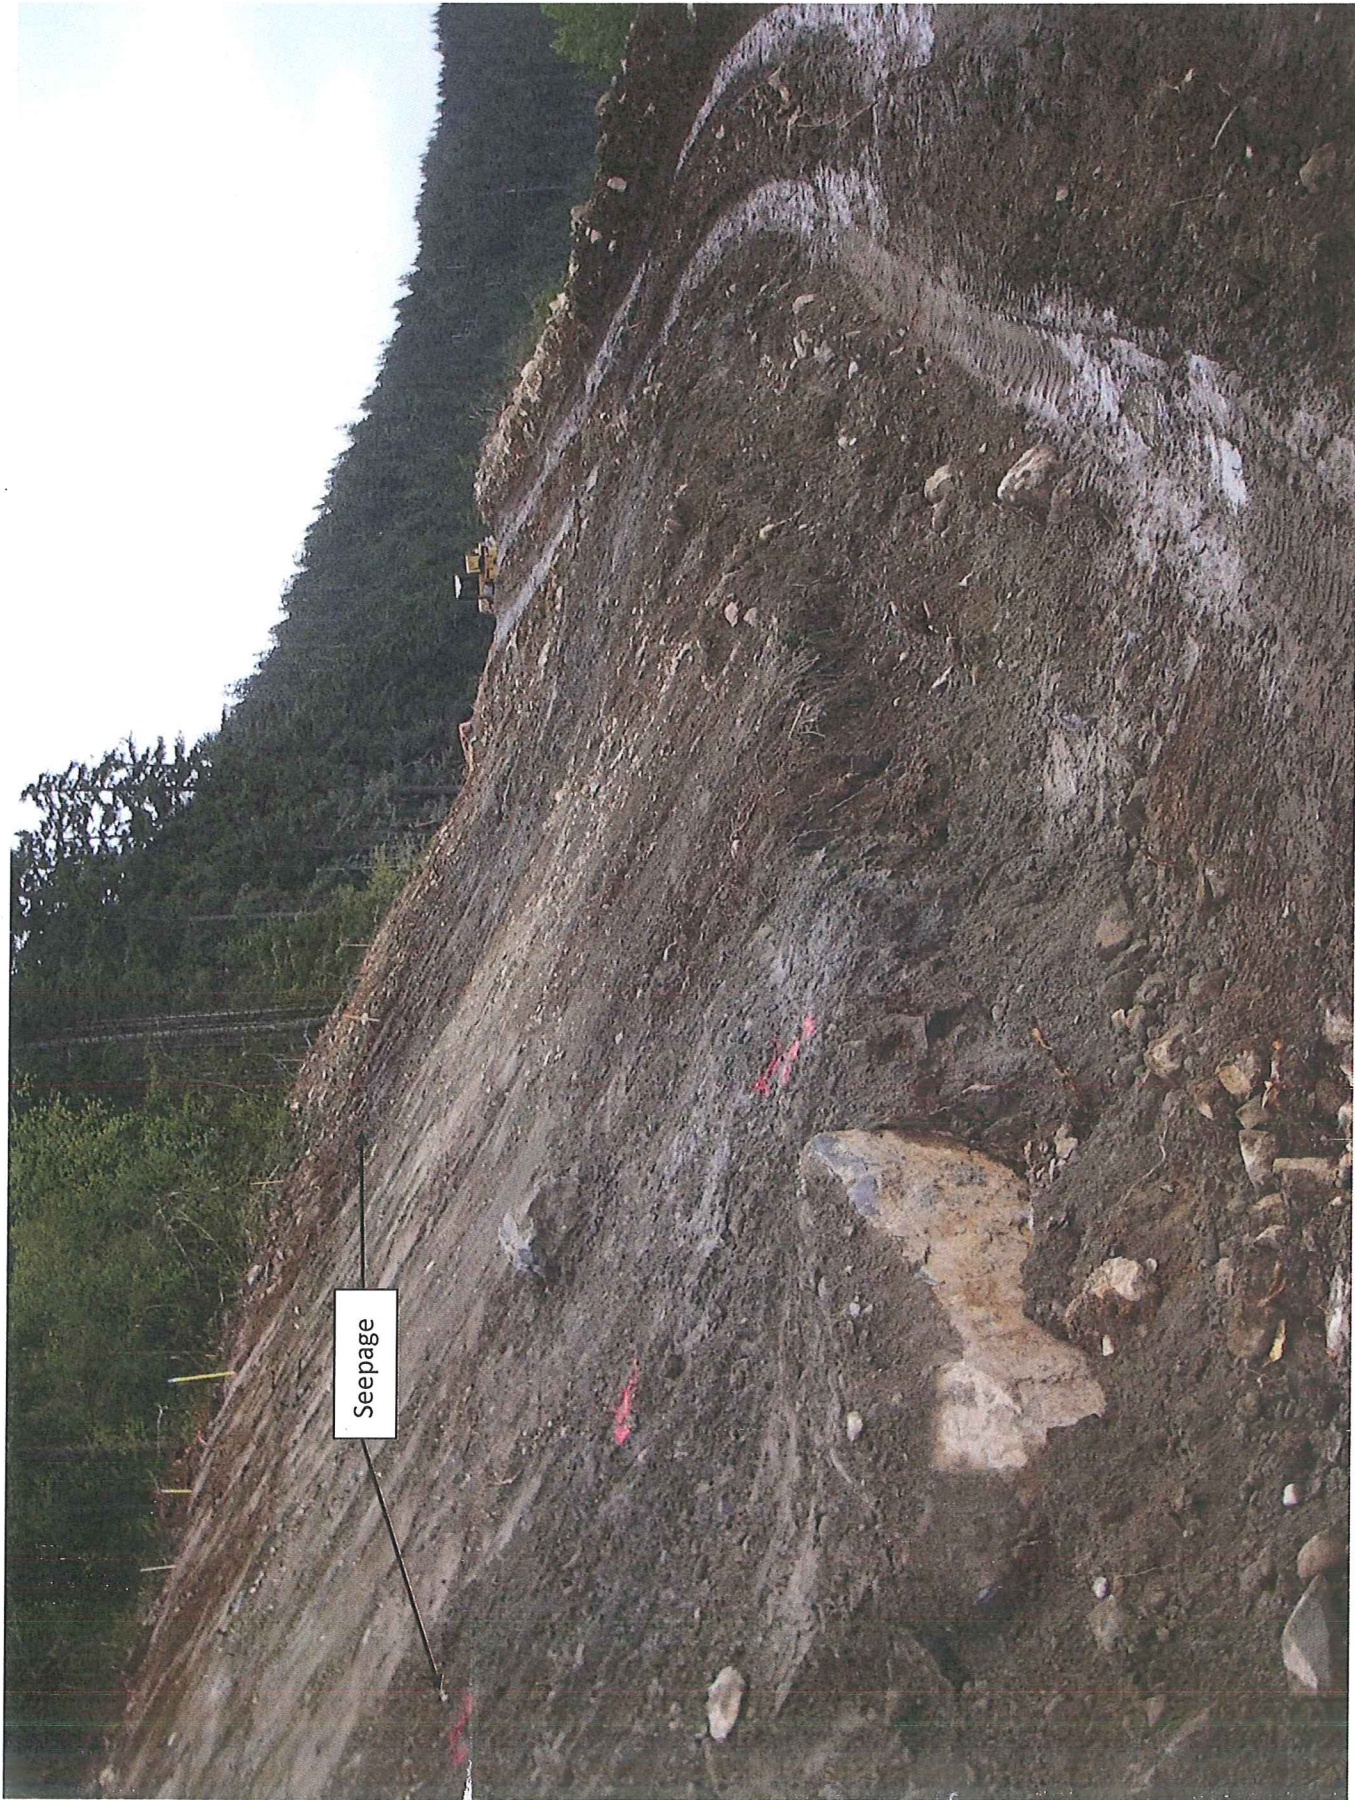
Brad and I walked over to approximate LW station 1341+65 to 1343+50 to discuss the recently exposed overburden. Currently, the overburden at this location was laid back at the recommended 1.25H:1V orientation and water was seeping out of the slope. Brad was concerned about possible erosion of the overburden from the groundwater. During my site visit, there was little to no evidence of erosion. I indicated to Brad that if the slope begins to erode there are many options to mitigate the minor erosion. A couple options we discussed were to tight line the water down slope to the ditch or possibly muck out the eroded portion of the slope and replace it with quarry spalls. We agreed that he would monitor the slope, especially during the wet seasons, and we would discuss mitigation options at a later date, if and when the slope erodes.

Figure 3. A photograph looking at the overburden section from approximate station 1341+65 to 1343+00.
